NEW TECHNOLOGIES FOR THE STRUCTURAL REHABILITATION OF MASONRY CONSTRUCTIONS: CONCEPT, EXPERIMENTAL VALIDATION AND APPLICATION OF THE CAM SYSTEM

SUMMARY

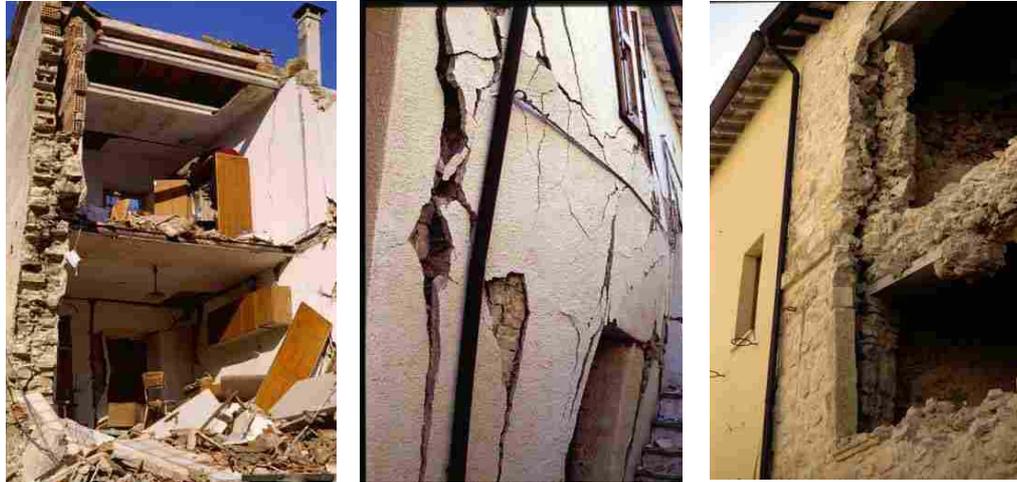
Fig. 1 - Collapse mechanisms of old Italian buildings (Umbria-Marche 1997 Earthquake).

Historical Italian buildings are generally characterised by low mechanical properties of masonry, both for its texture and for the bad quality of mortar. Walls are often made of a double masonry layer (see fig.1), without any transverse link [1, 2, 3]. Moreover masonry is not homogeneous, parts of the same wall being made of different materials. The low strength of

masonry structures is further reduced by the actual slenderness of the single wall layers, subjected to in-plane vertical compression and shear, as well as to out-of-plane bending. These combined actions produce the typical masonry collapses shown in fig. 1, even for low-medium intensity earthquakes [1]. When rehabilitating old masonry buildings, the main problems to solve are, therefore, not only relevant to the connections between structural elements (walls, beams, kerbs), but also to masonry weakness. In this respect the most popular kind of intervention is by far the jacketing of masonry, by using shotcrete and light steel net reinforcement [4], as also recommended by the Italian Ministry of Public Work [5], along with other kinds of strengthening. Though appealing for simplicity, low cost and speed of application, this intervention presents several drawbacks:

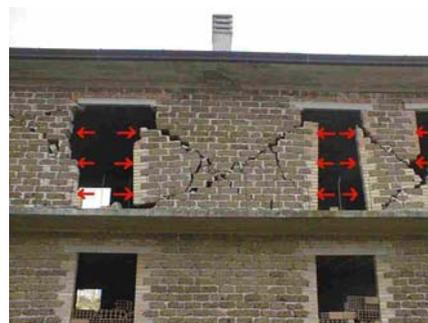
Fig. 2 – Failure mechanism of a new building.

It belongs to the category of “horizontal and vertical ties”, which is one of the four categories of strengthening techniques considered in [5]. It is completely realised with stainless steel, to avoid any durability problem and get good ductility characteristics. Ties are realised with steel ribbons and are pre-stressed, to apply a light pre-compression state, which is particularly useful in the transverse direction. Special connection elements permit to realise a continuous tying system, running all along masonry walls, both horizontally and vertically, to improve not only the shear resistance but also the flexural resistance of masonry walls in their single parts and as a whole. The potential of CAM in improving also the behaviour of recent masonry constructions is evident when observing fig. 2: horizontal ties would apply the lateral confining forces shown in fig. 2, thus contrasting the shear collapse mechanism.

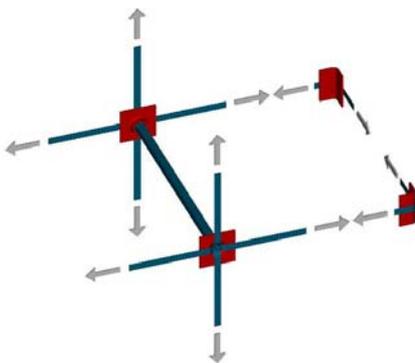
Fig. 3. CAM – basic arrangement.

The CAM system is mainly based on the use of stainless steel ribbons, to tie masonry with loops passing through transverse holes, as shown in fig. 3. The loops are closed with a special tool, which is able to apply a calibrated prestress to the ribbon. The system includes also drawpieces as connection elements and angles as terminal elements, as shown in fig. 4.

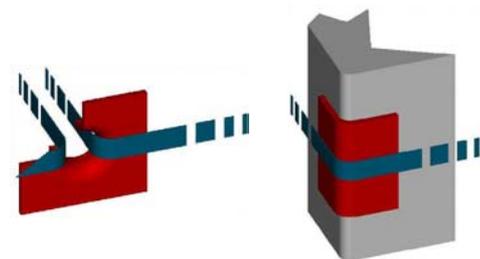
a) Connection plate

b) Terminal angle

Fig. 4 - CAM – basic elements.

In current applications, the ribbon is 0.75-0.80 mm thick and 18-20 mm wide, with yielding and failure strengths equal to 250-300 and 600-700 Mpa respectively, and more than 40% elongation at failure. The drawpieces, which play the role of connection and force transmission elements between adjacent ribbon loops as well as stress distribution elements on masonry, are usually 125x125 mm, 4 mm thick. Similar sizes are used for angles in current applications. The distance between holes is typically between 1000 and 2000 mm.

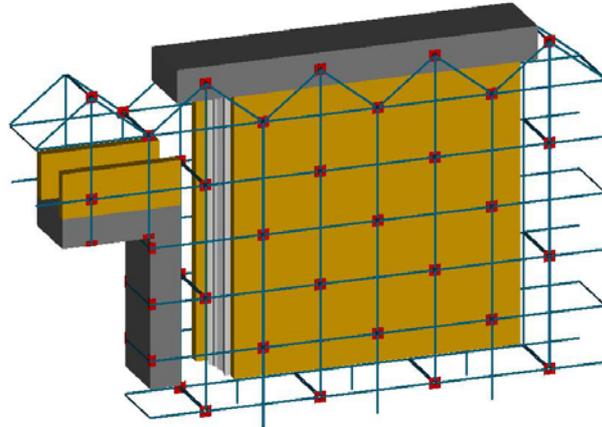
Fig. 5 – CAM - arrangement in a wall with a door and a R/C upper kerb.

The ribbon system can be arranged in a squared, rectangular, rhombic, triangular or even irregular mesh, so that a horizontal and vertical continuous sling is realised. Fig. 5 shows a typical application on a double layer wall, with an alternate arrangement of holes, to minimise their number. The holes can be eventually injected with any kind - there being no corrosion problems - of mortar, to improve masonry characteristics around holes. Alternatively, diagonal arrangements of loops can be more effective for regular brick masonry walls, as well as to connect floor kerbs to masonry walls, as shown in fig. 5, to limit possible kerb-masonry slipping.

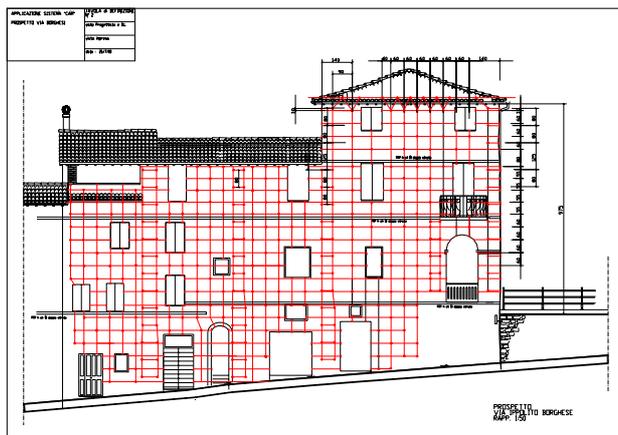
Fig. 8 - CAM arrangement in the facade.

of the steel ribbons (see fig. 8). A 60x60 cm mesh in the longitudinal walls and a 80x80 cm mesh in the transverse walls, with holes at 120 and 160 cm distance respectively.

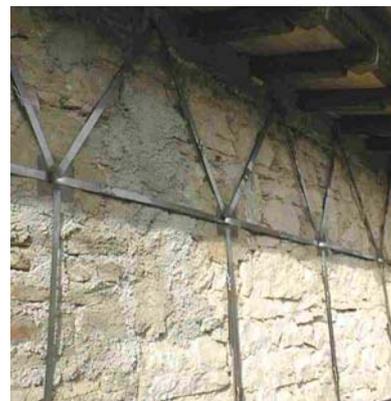
Fig. 9 – CAM arrangement in the facade and link to the top R/C kerb.

The original plasters have been removed wherever they had to be remade in any case (fig. 9). On the contrary the system has been applied by only making the strictly needed chases, wherever the plaster was in good conditions (fig. 10). The preparation of the surfaces, by plaster removing or chasing, was finalised to get a linear path, along and near the masonry surface, avoiding any contact between ribbon and masonry. Particular care was put in the correct positioning and bonding of the drawpieces and of the angles.

Figs. 9, 11 and 12 show the capability of CAM to improve the connections between different structural elements: R/C kerb and masonry wall (fig. 9 and 11), orthogonal masonry walls (fig. 11). The big size angles in fig. 11 are used to realise a good connection of orthogonal walls, where the ribbons of the two walls are outset.

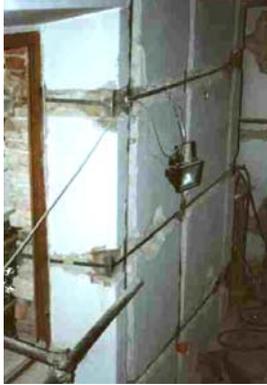
Fig. 10 – CAM arrangement in chase.

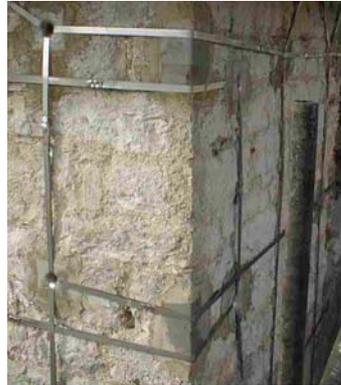
Fig. 11 - Detail of the connection between orthogonal walls.

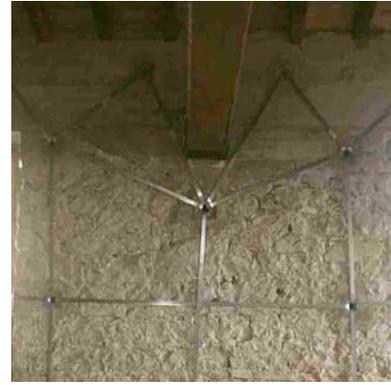
Fig. 12 - Detail of the link to the R/C kerb around a wooden truss.

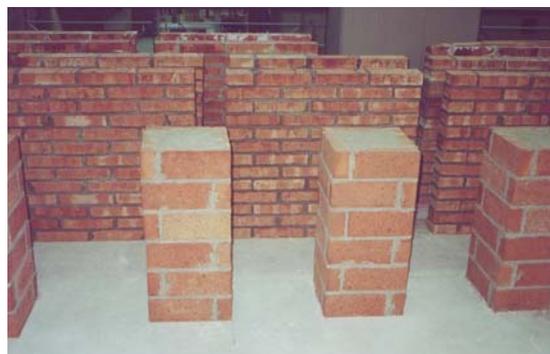
Fig. 13 – Panels and columns before testing.

evaluate the improvement of strength and ductility on in-plane stressed brick masonry with regular texture and on squared cross-section columns. At this end 50 panels, about 90x90x12 cm, to be subjected to diagonal compression tests and 20 columns, about 32x32x82 cm, to be subjected to simple compression tests were built. The panels are made of different types of mortars, defined in [7] as M2 (cement mortar), M3 (cement lime mortar), M4h (hydraulic lime mortar), M4c (cement lime mortar). The columns were made of an external brick masonry stretcher layer and cast masonry inside. Masonry panels and columns are shown in fig. 13. Before testing masonry specimens, stainless steel ribbon specimens, also including the connection joint, have been tested in traction, to evaluate their strength and ductility characteristics.

20 columns were realized with an external 5 cm-thick brick layer and filled with mortar of low quality and brick pieces (see fig. 13). Low quality mortar, having 0.8 N/mm^2 compression strength and $0,29 \text{ N/mm}^2$ flexural strength, was used. Different CAM configurations were analyzed, as shown in figure 20. They differ each other for the number of ribbons and the continuity of the steel angles along the height of the column.

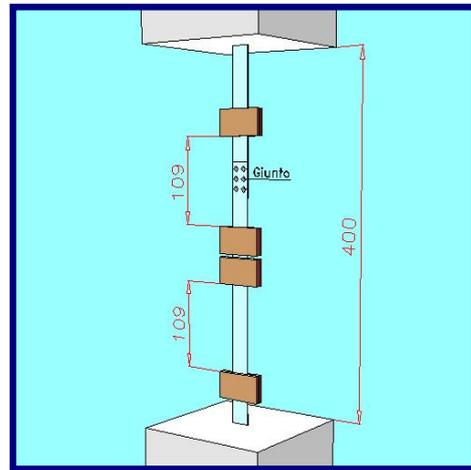
Fig. 14 – Test set up for steel ribbons.

20 specimens of AISI 304 stainless steel were tested. Ten specimens were made of two ribbon pieces joined together. The force-displacement diagram was recorded on a 109 mm measurement base around the joint and on plane ribbons and on a 400 mm base, as shown in fig. 14. In fig. 15 there are reported some typical stress-strain diagrams. In fig. 15 a) the behaviour of just stainless steel is shown. Elongation at failure of the order of 60% are attained. The mean value of stress, obtained from the ten specimens tested, is 610.20 N/mm², with 0.6% coefficient of variation. In the same diagram there is also reported the curve relevant to the ribbon with joint. As can be seen the failure strength is reduced by about 25%, the mean value being equal to 446.55 N/mm², with 1.5% coefficient of variation. Nevertheless, even the

ribbon with joint shows a considerable ductility, as the average elongation at failure is greater than 10%. In fig. 15 b) the curves taken on the three different bases, as shown in fig. 14, clarify the behaviour of the ribbon with joint. The elongation measured on the parts of ribbon with and without joint are of the same order, resulting in the spread of yielding beyond the joint, all along the ribbon, due to the marked strain hardening of stainless steel of ribbons. The large elongation capacity of the stainless steel ribbon results in a great ductility capacity of the CAM system when applied to masonry panels.

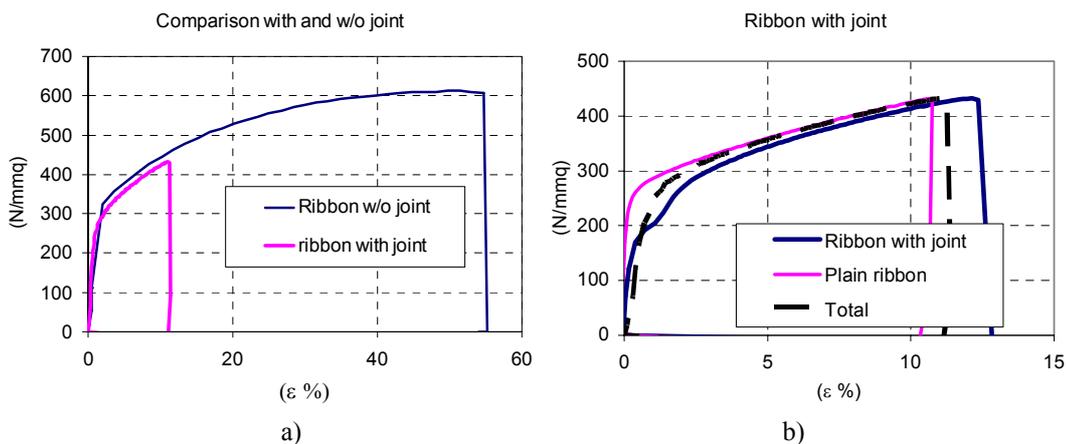
Fig. 15 – Experimental stress-strain diagrams of stainless steel ribbons.

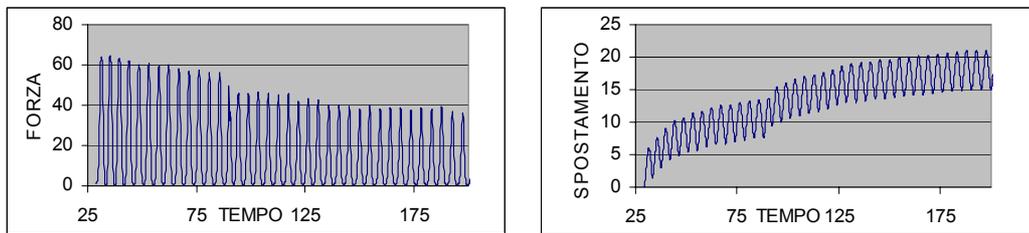
Fig. 16 – Testing procedure of the cyclic loading-unloading tests.

strengthening failed panels with CAM. Each panel has been first tested up to failure, then strengthened by applying CAM and tested again. The initial test on both unstrengthened panels have been carried out with monotonic load, while the one of the strengthened panels has been tested monotonically, the other under loading-unloading cycles, as described by the force-time and displacement-time diagrams of fig. 16.

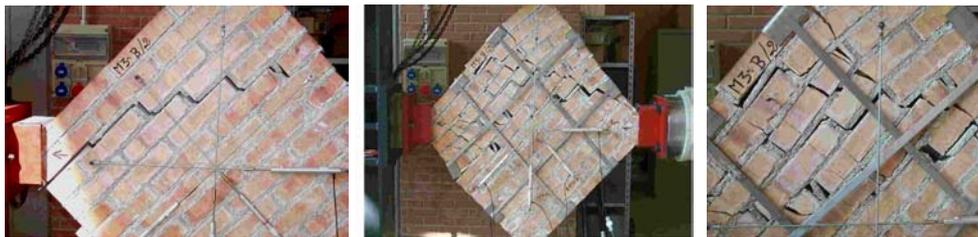
Fig. 17 - a) Failure of the unstrengthened panel b,c) failure of the same panel repaired and strengthened with the CAM System.

Fig. 17 shows the state of panel M3-B2 without strengthening at the end of the first test (picture a), and with strengthening, at an intermediate step and at the final step (pictures b, c). The repairing with CAM stops the crack separation started in the previous test and favours a crack distribution involving the entire panel, thus dissipating a large amount of energy.

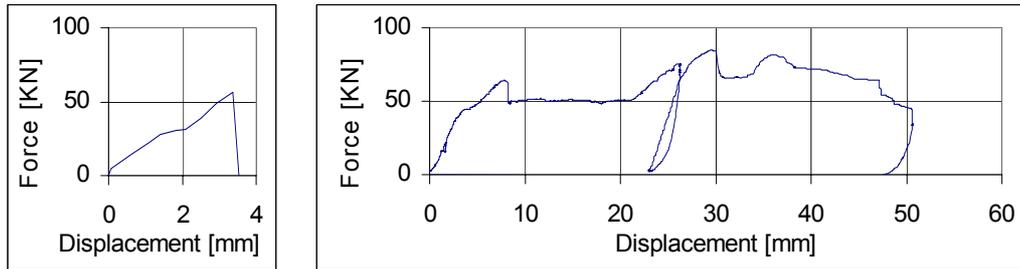
Fig. 18 - Diagonal force-displacement diagram of panel M3B2 without and with CAM.

Fig. 18 shows the force-displacement diagrams of panel M3-B2, without and then with CAM strengthening, under monotonic load in both cases. Strength and ductility gains are evident. A considerable percentage of diagonal load capacity is kept up to 4-5 cm displacement.

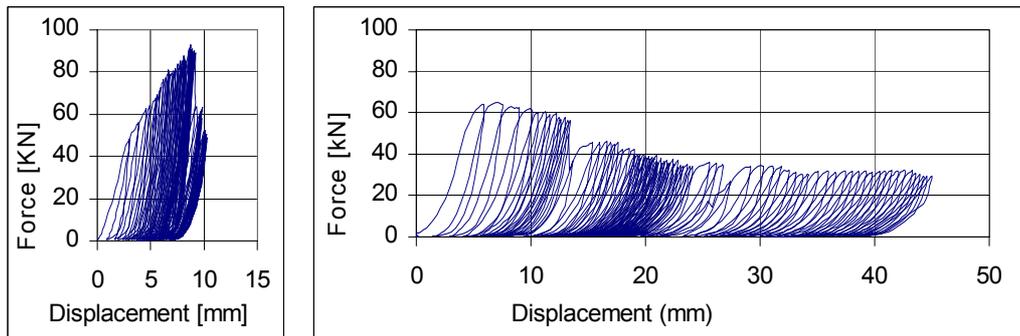
Fig. 19. Diagonal force-displacement diagram of panel M3B1 with CAM strengthening in the third and fourth series of cycles.

Fig. 19 shows the force-displacement diagrams of panel M3-B1, tested with CAM strengthening, in the 3rd and 4th series of cycles. In the third series the maximum strength value has been reached for 9 mm displacement (in that series). In the fourth series the residual strength, equal to about 30% of the maximum strength, is kept constant for very large displacement and a very large number of cycles.

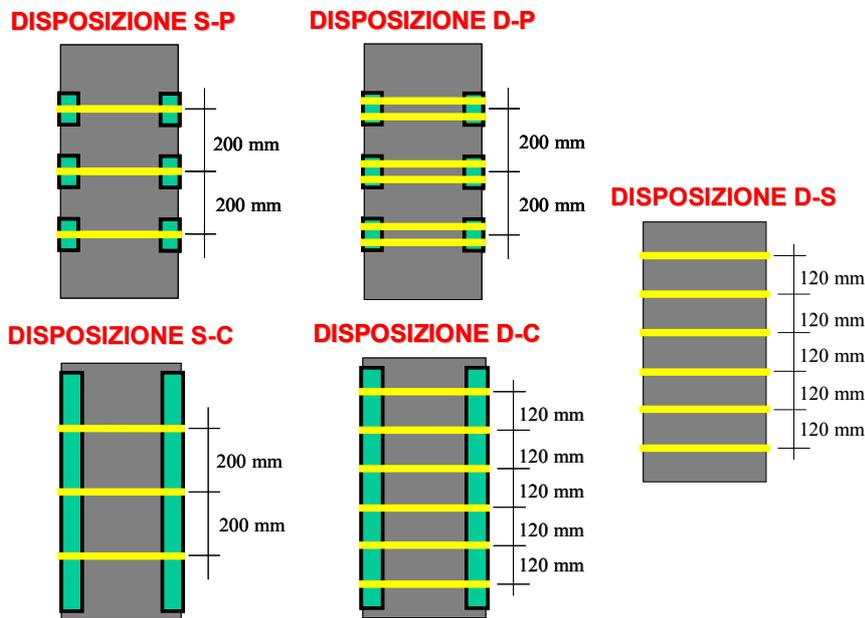
Figure 20 - Configurations of the ribbons used for the tests

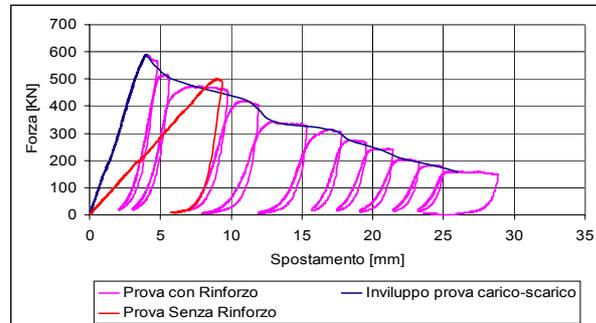
Fig. 21 – Force-displacement diagram of column 1

Fig. 21 shows a typical force-displacement diagram of a column. The curves relevant to the initial test on the unstrengthened specimen, to the cyclic loading-unloading test on the strengthened specimen and the envelope curve of the cyclic test can be distinguished. The increase of strength and the much greater stiffness (about 2.5 times) of the specimen after

strengthening are apparent, as well as the sudden drop of force of the unstrengthened column and the capability of the strengthened column to undergo several loading-unloading cycle. However, while the increase of strength is due to the CAM strengthening, the increase of stiffness is to be ascribed to the bad quality of the mortar in the joints, specifically to its porosity. It is compressed during the first cycle, reducing its volume and increasing its stiffness, independently of CAM strengthening.

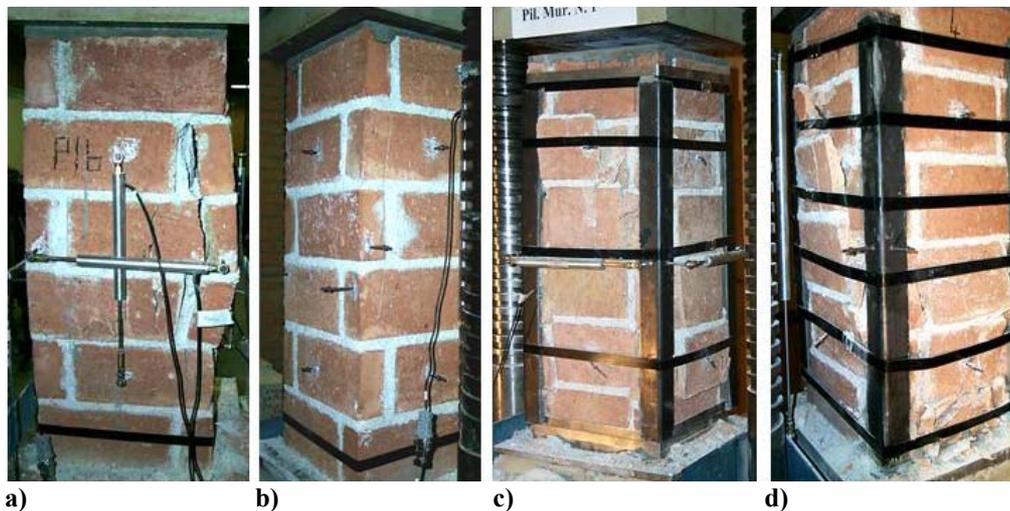
Fig. 22 – Column specimens under tests: a) typical failure mechanism of unstrengthened specimens due to brick layer instability, b) failure of column 1 before strengthening, c) failure of column 1 after strengthening, d) failure of column 6.

Fig. 22 shows some examples of column specimens under tests. Picture 22a) shows a typical failure mechanism of an unstrengthened specimens, compressed up to reaching a residual strength less than half its maximum strength. The failure is clearly due to the instability of the brick layer, occurring when some bricks break up near the corners. Picture 22b) shows the failure of column 1 before strengthening, when the residual strength was 98% its maximum strength. It is again due to the incipient instability of the brick layers, favoured by the failure of some bricks at the corners. Pictures 22c) and 22d) show the failure of column 1 and column 6 after strengthening. Even in this case the failure is generated by the instability of the external brick layer, which is however contrasted by the confining actions of the ribbon-angle system.
