Experimental Tests on Typical Masonry of Messina Area (Italy) Retrofitted with CAM: a Full Scale Arch

Keywords: Masonry, In-Plane Shear, CAM, Arch

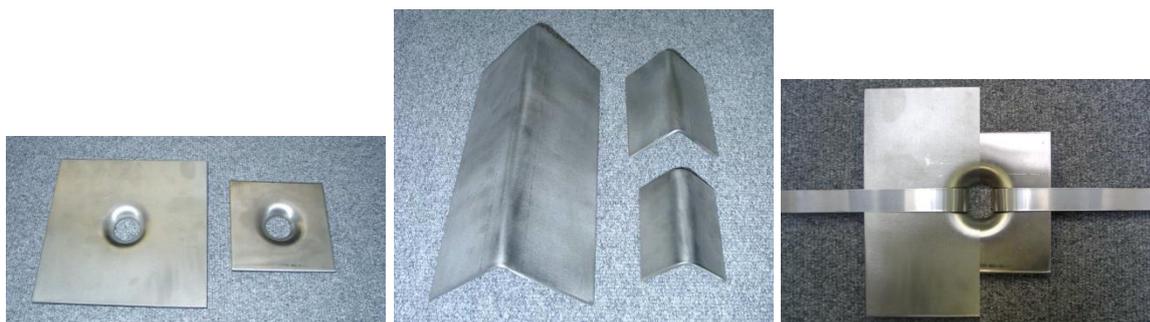
Figure 1. Stainless steel a) plates; b) angular elements; and c) ribbons.

The CAM system is mainly based on the use of stainless steel ribbons, to tie masonry with loops passing through transverse holes, as shown in Figure 1(c). The loops are closed with a special tool, which is able to apply a calibrated prestress to the ribbon. The system includes also drawpieces as connection elements and angles as terminal elements, as shown in Figure 1(b).

In current applications, the ribbon is 0.9-1 mm thick and 19 mm wide, with yielding and failure strengths equal to 250-300 and 600-700 MPa respectively, and more than 40% elongation at failure. The drawpieces, which play the role of connection and force transmission elements between adjacent ribbon loops as well as stress distribution elements on masonry, are usually 125×125 mm, 4 mm thick [Figure 1(a)]. Similar sizes are used for angles in current applications. The distance between holes is typically between 400 and 800 mm.

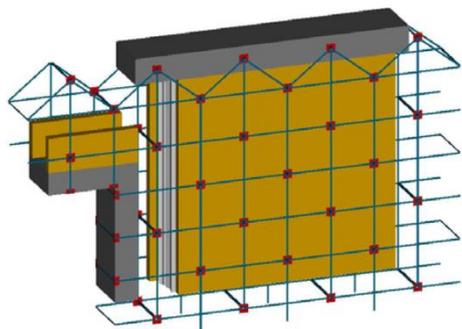
Figure 2. CAM arrangement in a wall with a door and a R/C upper lintel.

The ribbon system can be arranged in a square, rectangular, rhombic, triangular or even irregular mesh, so that a horizontal and vertical continuous mesh is realised. Figure 2 shows a typical application on a double layer wall, with an alternate arrangement of holes, to minimise their number. The holes can be eventually injected with any kind of mortar provided there will be no corrosion problems, to improve masonry characteristics around holes. Further, diagonal arrangements of ties can be more effective for regular brick masonry walls, as well as to connect floor lintels to masonry walls to limit possible lintel-masonry slipping.

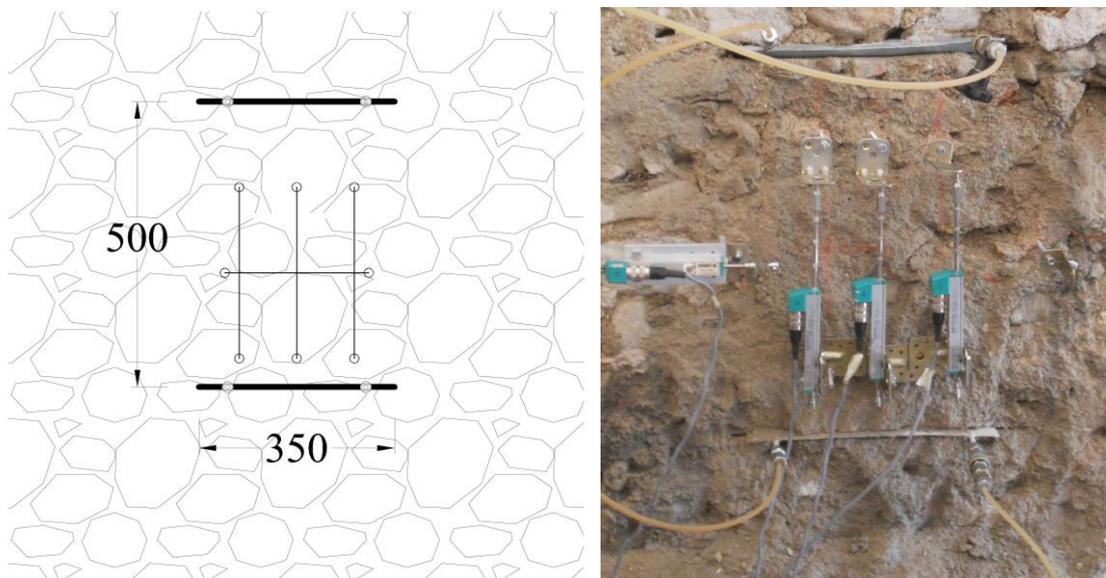
Figure 3. Double flat-jack test: a) setup and b) preparation (dimensions in mm).

A test with double flat-jacks was performed on the ancient masonry of the building at a wall orthogonal to the considered arch. The objective was to estimate the compression strength in the masonry walls with irregular texture. The flat-jack test technique is a relatively well known semi-destructive one. After the creation of two horizontal slots in the masonry, the compressive stresses present at that point cause the closure of the masonry above and below each slots. Before cutting the

wall, original dimensions are taken between gage points. Once the cuts are made, the flat-jacks are loaded in the cuts and readings between the gage points are taken at various pressures. From this data, one can back calculate the stress present in the wall before the cuts were made as well as the modulus of elasticity of the masonry. After data for both tests are obtained, the cuts are restored to their original conditions with mortar.

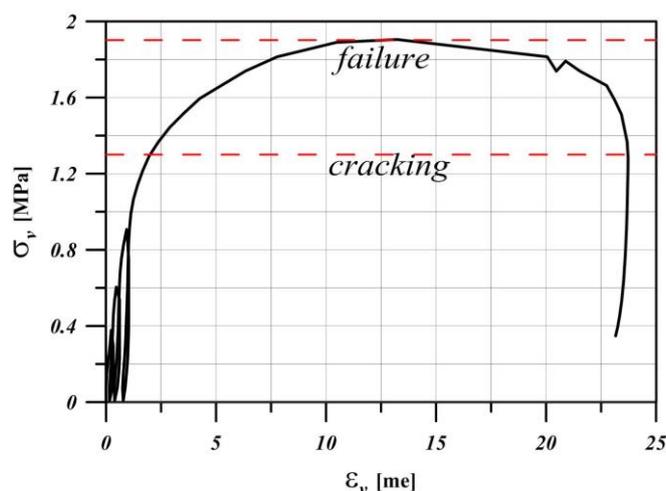
Figure 4. Double flat-jack test: average stress–strain curves.

where K_a is a factor that accounts for the ratio between the bearing area of the jack in contact with the masonry and the bearing area of the slot; K_m is the factor accounting for the physical characteristic of the jack, and p is the pressure required to restore the gauge points to their original distance. Both the single and double flat-jack tests were conducted with respect to the recommendations issued by the American Society for Testing and Materials [8,9], due to the lack of references on Italian rules. For the execution of the in-situ tests the following equipment was used: semi-oval flat-jack (dimensions: 350x260x4 mm with $K_m = 0.84$ and $K_a = 0.90$); hydraulic circular saw ($\varnothing 350$ mm and thickness 3.5 mm); hydraulic hand pump (manometer with ranges of 20 and 60 bar); mechanical strain gauge (length 200 and 400 mm, with resolution equal to 0.001 mm). Figure 3 reports the scheme of the test (acquired geometry and position of the bases measurement of the removable strain-gauge), and Figure 4 reports the outcome of the double flat-jack test where vertical strains are plotted as functions of the stress in the wall (mean stress–strain curves).

The results show a weak masonry with a compression strength equal to 1.90 MPa, while the first crack was appeared at a level of compression stress equal to 1.30 MPa.

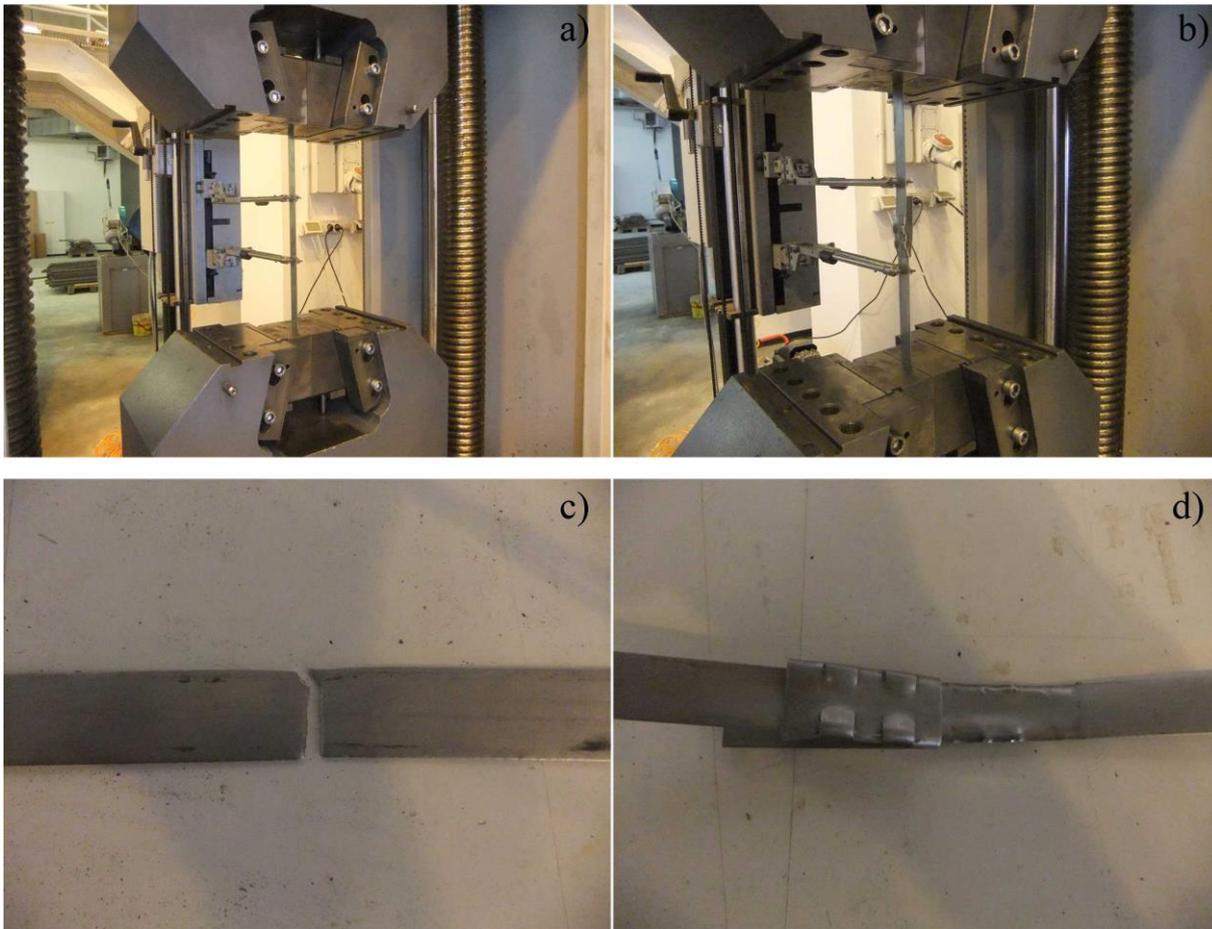
Figure 5. Stainless steel tests: preparation a) without and b) with joint; failure mode c) without and d) with joint.

The mechanical property and the junction of the stainless steel ribbon affects the efficiency of the CAM system. With the purpose of investigating the efficiency of the reinforcement system, the stainless steel used for the ribbons was subjected to uniaxial tensile test. The stainless steel was chosen to give a minimum characteristic yield (f_{yk}) and a minimum failure (f_{tk}) characteristic strength equal to 220 MPa and 540 MPa, respectively. In detail, six specimens of stainless steel were tested: three with and three without junctions. A servo-hydraulic machine, with a 4000 kN load-carrying capacity, was used for the tensile tests of stainless ribbons, adopting a gauge length of 100 mm as shown in Figure 5(a,b). The specimens without junctions exhibited a classical failure mode characterized by considerable elongation and subsequent necking of the cross-section [Figure 5(c)]; the specimen with the junction at the middle height showed a failure mode characterized by successive losses of load corresponding to slips of the junction [Figure 5(d)]. In Figure 6 the tensile stress-strain curves for each specimens are plotted. The ribbons show a good capacity of axial deformation, with the maximum strain value about of 50 me. The constitutive behaviour for ribbons without junction is typical of stainless steel and the experimental yield strength is higher than expected value of 220 MPa (Figure 6). The specimens prepared with the junctions in the middle are able to reach values of strength less than the corresponding specimens without junction, and the deformation capacity is reduced, as showed in Figure 6. Moreover, for the sealed specimens brittle failure of the junction was observed and the corresponding ultimate strain recorded is about of 5 me (Figure 6).

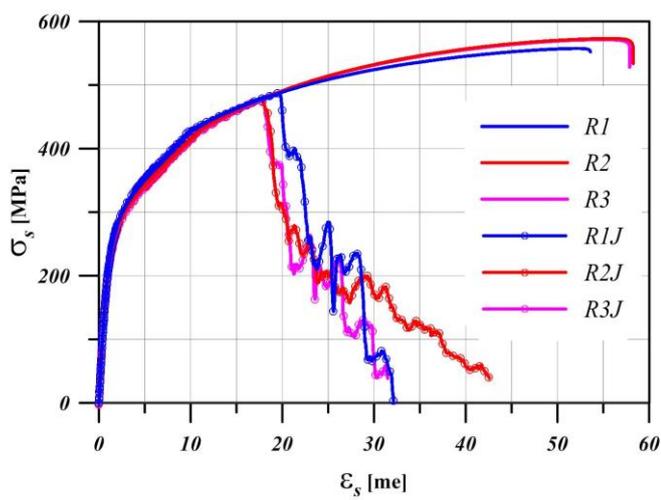
Figure 6. Stainless steel tensile tests: average stress–strain curves for ribbons with (R#) and without (R#J) joint.

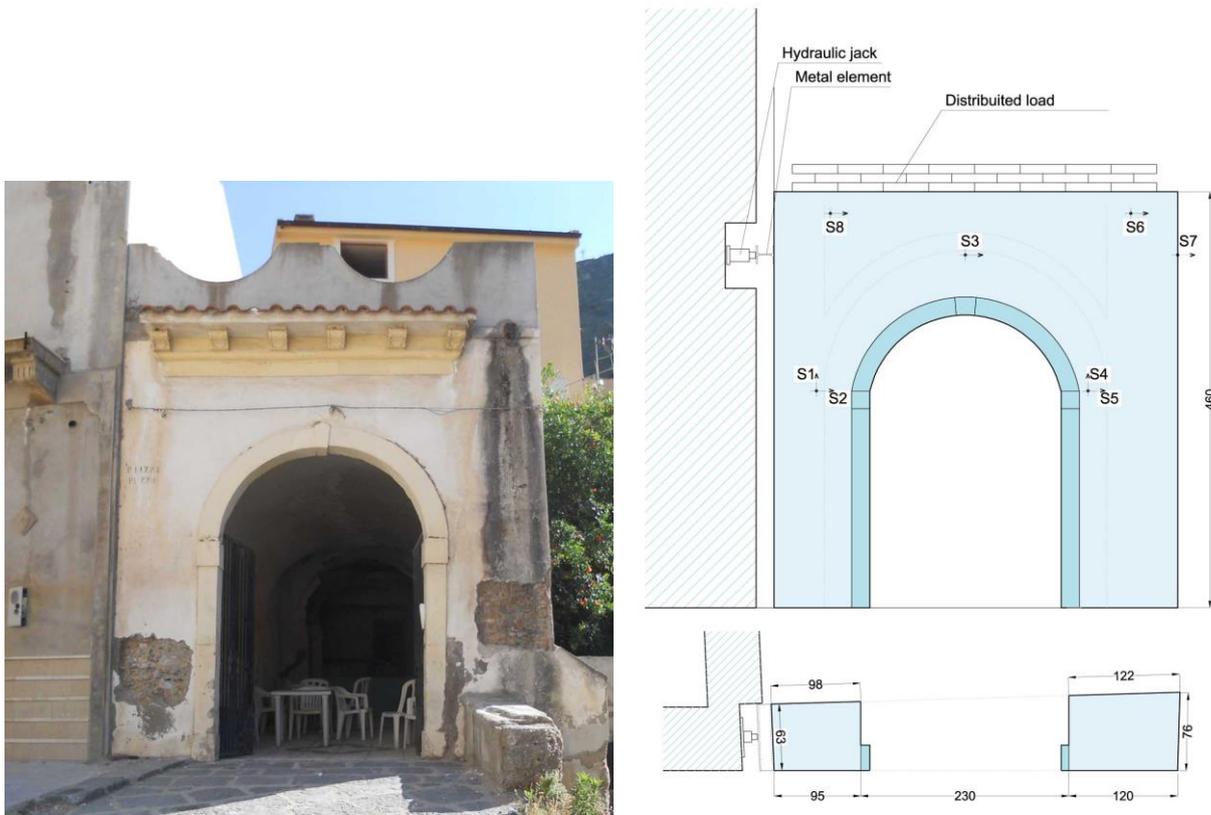
Figure 7. Unreinforced arch: a) preparation and b) setup (dimensions in cm).

The arch chosen for the investigative campaign was part of an ancient masonry building destined for demolition [Figure 7(a)]. The preparation phase of testing was characterized by the following steps: (1) the external plaster was removed; (2) the railing on the top was demolished; and (3) the masonry wall was isolated from the rest of building with a diamond circular saw. With the aim to obtain a fixed reference for measurements, a light steel frame was built close to the front face of the arch; then eight Linear Variable Differential Transformer (LVTDs) were positioned in different points of wall [Figure 7(b)].

The LVDTs S1 and S4 measured the displacements on the left abutment along the vertical and horizontal direction, respectively; on the right abutment, the corresponding LVDTs were S2, vertical, and S5, horizontal; along the horizontal load line, the LVDT S3 was positioned at the middle of the wall, above the keystone, while the LVDT S7 was positioned on the opposite side with respect to the hydraulic jack to measure the global horizontal displacement; the LVDTs S8 and S6 measured the horizontal displacement and were positioned at the top-left and top-right of the wall, respectively. In addition, to check eventual dangerous out-of-plane displacements, two LVDTs orthogonal to the internal wall face and on the same level of LVDTs S8 and S6 were used.

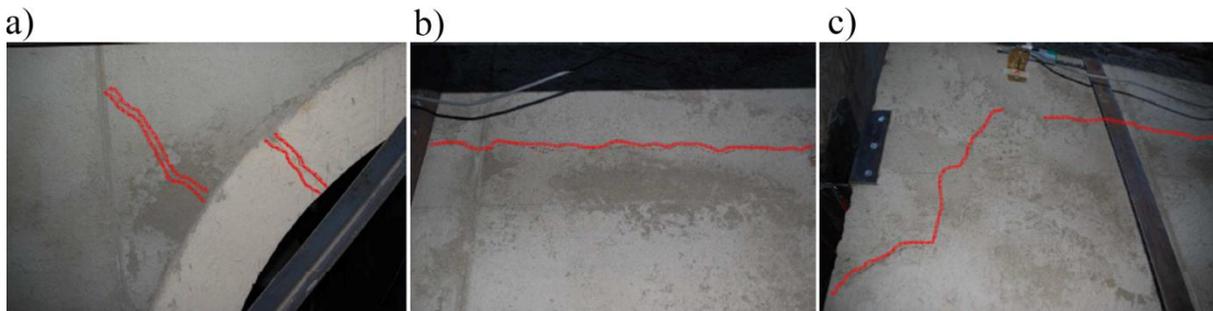
Figure 8. Unreinforced arch: first cracks.

The first test was carried out on the unreinforced arch. The load was applied by several cycles and incremented until some cracks were appeared. The cracks were formed respectively: (a) in correspondence of the left haunch of the arch; (b) a long horizontal crack close to the top of the wall; and (c) close to the point load (Figure 8). In Figure 11, the curves load-displacement, show the capacity of unreinforced arch both in terms of crack strength and ductility. The maximum load was equal to 50.6 kN, which was reached at a corresponding horizontal displacement (S7) of 5.4 mm [Figure 11(h)]. The left abutment was subjected to a tensile stress, while the right abutment was compressed as expected [Figure 11(c,d)]. In the part of arch over the keystone the measured horizontal displacement was about the same for the LVDTs S8, S6 and S3 [Figure 11(e-g)], because just few parts of masonry were cracked.

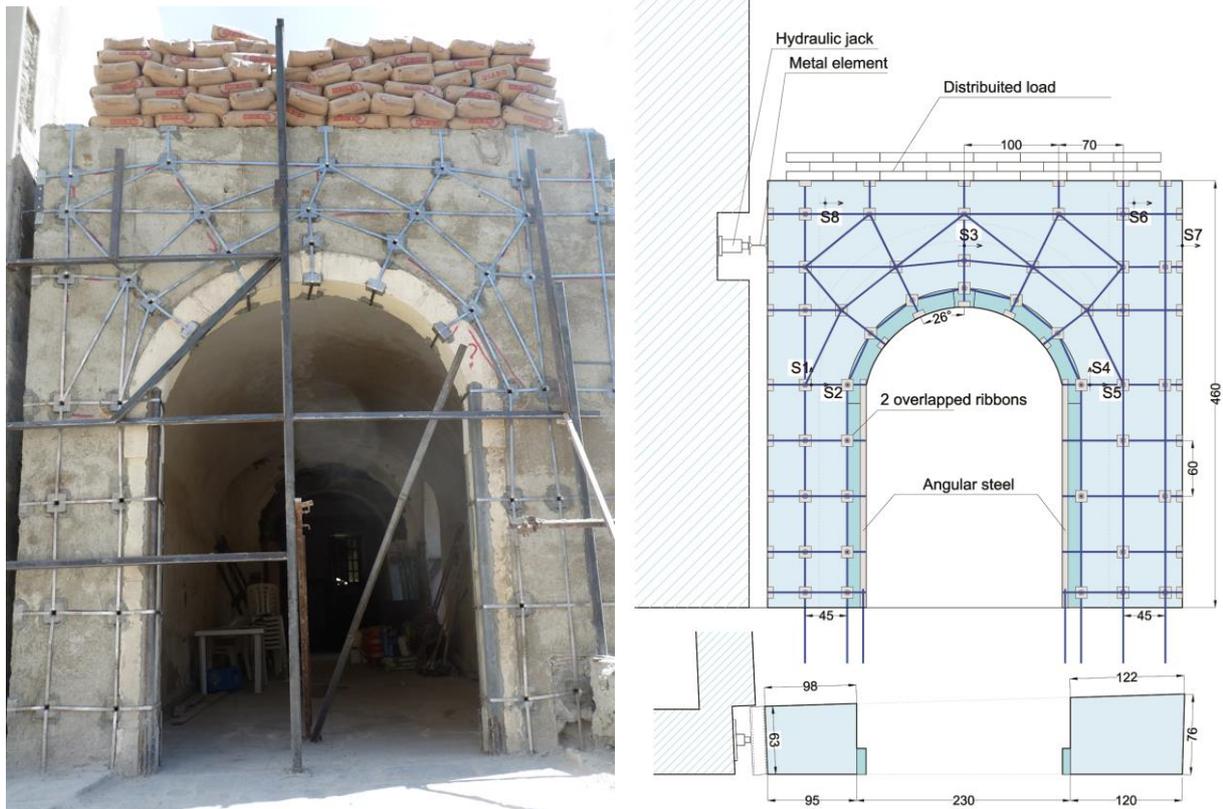
Figure 9. Reinforced arch: a) preparation and b) setup (dimensions in cm).

In the second phase of tests, the constant vertical compression load was removed to allow the retrofitting of the arch with the CAM system. Two overlapped ribbons of stainless steel was used to confine the masonry along the face of the masonry and in the orthogonal direction to the arch plane, with ribbons passing through the holes drilled in the masonry. The ribbons scheme adopted is showed in Figure 9, with a squared arrangement of stainless steel ribbons along the abutments, while a radial arrangement was adopted for the masonry over the keystone. The radial stainless steel ribbons were positioned orthogonal to the haunch of arch. Moreover, four steel angular were used to reinforce the inner edges of each abutments increasing their flexural strength (Figure 9). The adopted arrangement is representative of a realistic situation, which could be optimized in future applications avoiding some holes in the wall.

After the completion of the operations of the arch reinforcement with the CAM system, the constant vertical compression load equal to 7 kN/m was re-applied on the top of the wall [Figure 9(a)]. The removal and re-positioning of the constant vertical load has temporarily modified the stress condition, but no new cracks were observed before the test on the reinforced arch.

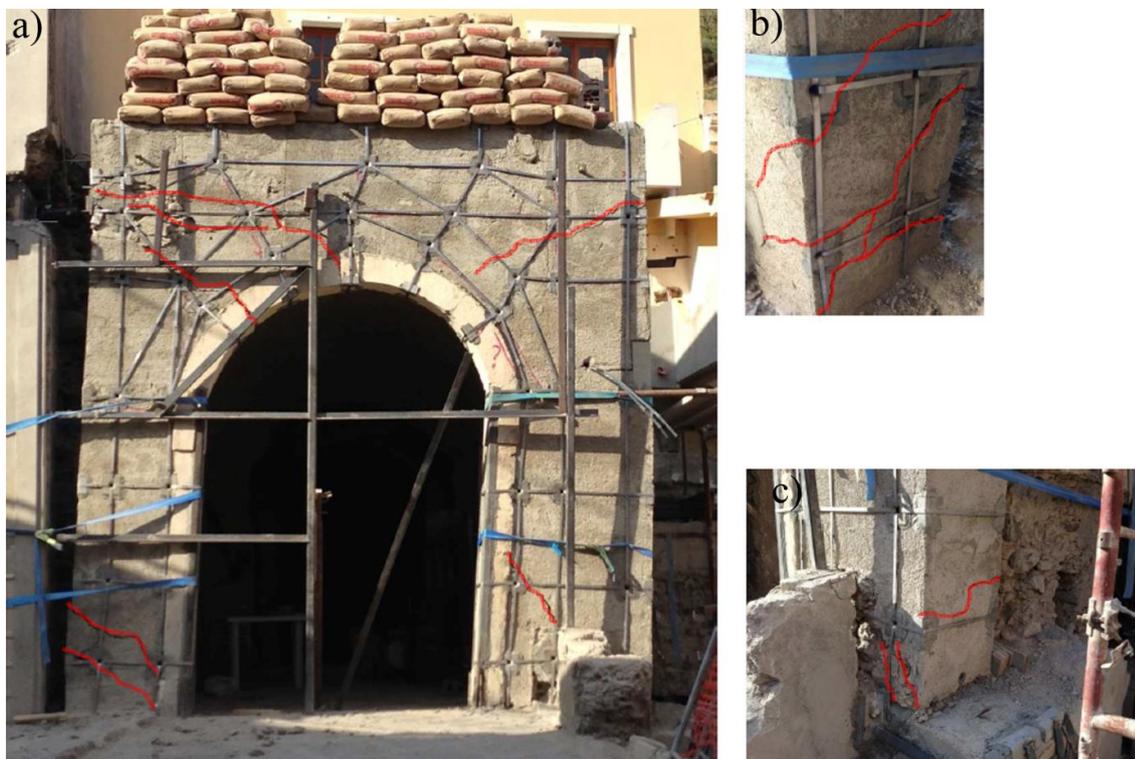
Figure 10. Reinforced arch: crack patterns before failure of a) arch; b) left abutment; and c) right abutment.

Then, horizontal load cycles having increasing displacement amplitude of 4 mm each cycle were applied. The maximum load of 111.1 kN was reached at the end of the 6th cycle, when the horizontal displacement reached about 70 mm. The observed displacement capacity of the arch reinforced with the CAM system was unexpected and higher than the elongation capacity of the hydraulic jack, as shown in Figure 10(a); thus the collapse of the structure was not reached.

At the maximum level load, both the feet of left and right abutments were subjected to tensile stress and wide cracks were formed [Figure 10(b,c)]. Other cracks were appeared across the top part of the wall. However the CAM system was able to confine the masonry, allowing the stress transfer across cracks. In addition, during the unload cycles, the wide cracks were always closed also for high load levels and limiting the plastic deformations.

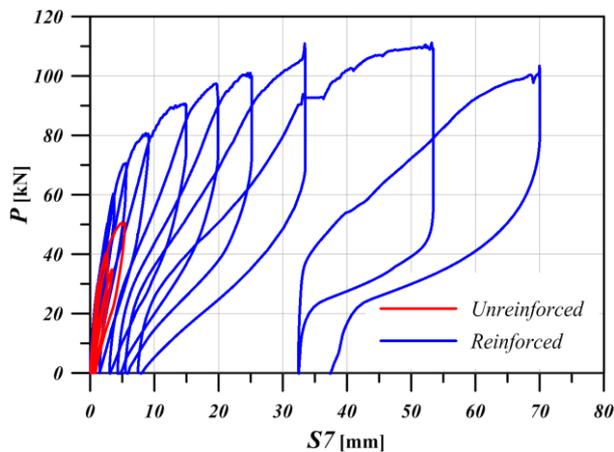
Figure 11. Horizontal load-displacement curve for unreinforced and reinforced arch.

The load-displacement curves obtained in the first (unreinforced arch) and second phase (reinforced arch) of tests are plotted together in the Figures 11 for a comparison of results. The maximum load was equal to 111.1 kN, which was reached at a corresponding horizontal displacement (S_7) of 70 mm [Figure 11(h)] with a percentage increment of 120% and 1196% of load and horizontal displacement, respectively.
